# **DIRTT ENVIRONMENTAL SOLUTIONS LTD.**

## **ACOUSTICAL PERFORMANCE TEST REPORT**

ASTM E90 SOUND TRANSMISSION LOSS TESTING ON SERIES/MODEL EVIL TWIN BACK-TO-BACK 4" SOLID WALL SYSTEM WITH SPECTRA™ DOUBLE PANE BUTT-HINGE DOOR

S3334.01-303-11

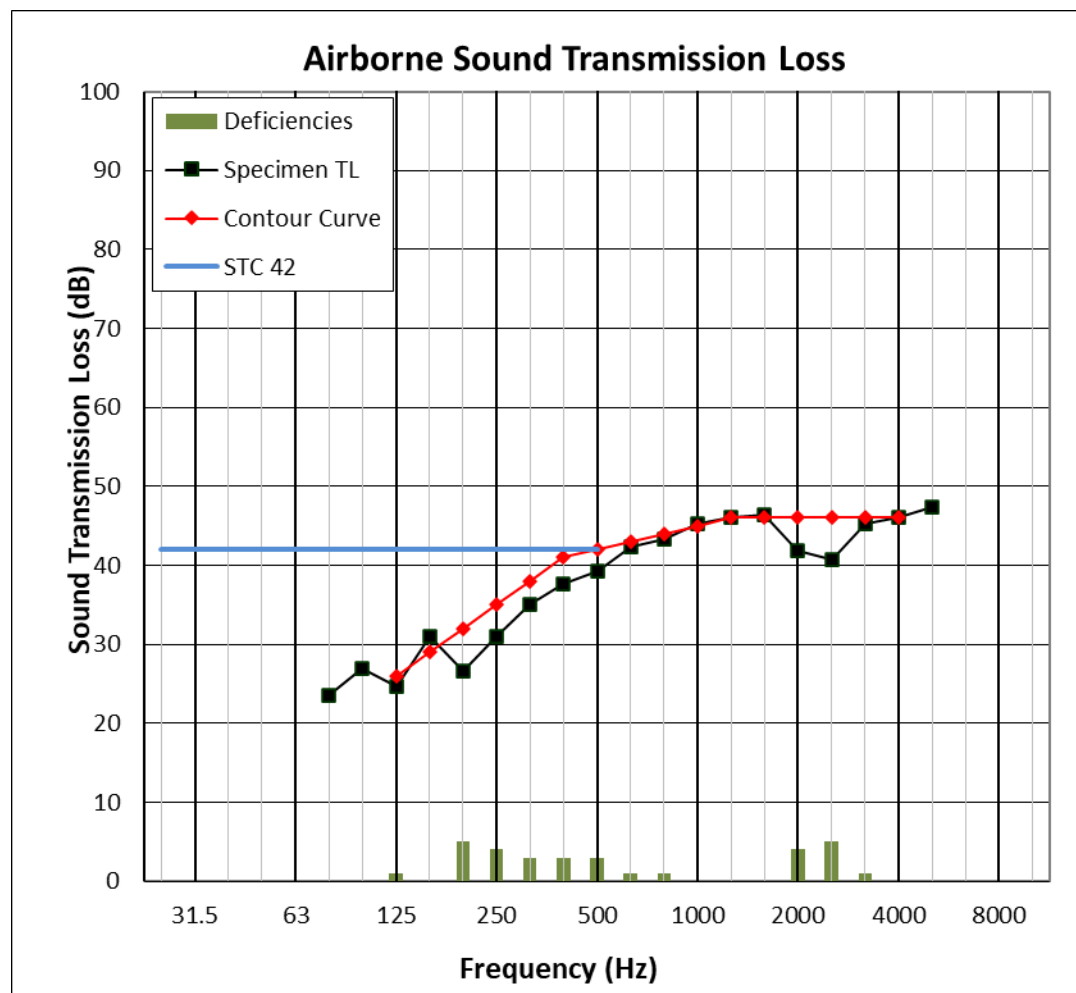
### ASTM E90

### AIRBORNE SOUND TRANSMISSION LOSS

| DESCRIPTION | Back-to-back- 4" (101.6 mm) thick Enzo solid wall with three layers of insulation and 1/2" (12.7 mm) MDF tiles finished with chromacoat, incorporating a Spectra™ double pane butt-hinge door with a 1-1/4" (31.75 mm) IG [1/4" (6.35 mm) tempered exterior glass, 13/16" (20.64 mm) airspace, and 1/4" (6.35 mm) tempered interior glass] | | | | |

| FREQ<br>(Hz) | BACKGROUND<br>SPL<br>(dB) | ABSORPTION<br>(m <sup>2</sup> ) | SOURCE<br>SPL<br>(dB) | RECEIVE<br>SPL<br>(dB) | SPECIMEN<br>TL<br>(dB) | 95%<br>SAMPLING<br>LIMIT (dB) | NUMBER<br>OF<br>DEFICIENCIES |
|---|---|---|---|---|---|---|---|
| STC RATING | 42 (Sound Transmission Class) | | | | | | |
| OITC RATING | 34 (Outdoor-Indoor Transmission Class) | | | | | | |

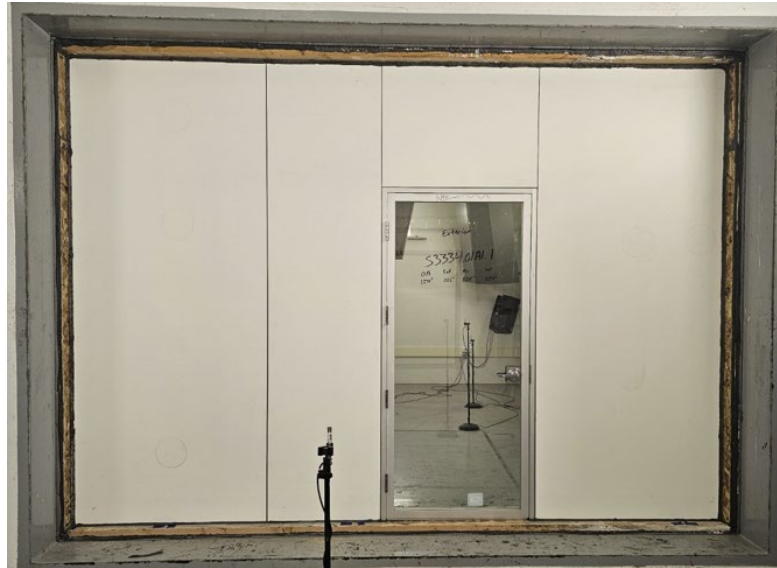
Photo No. 1

Source Room View of Installed Test Specimen

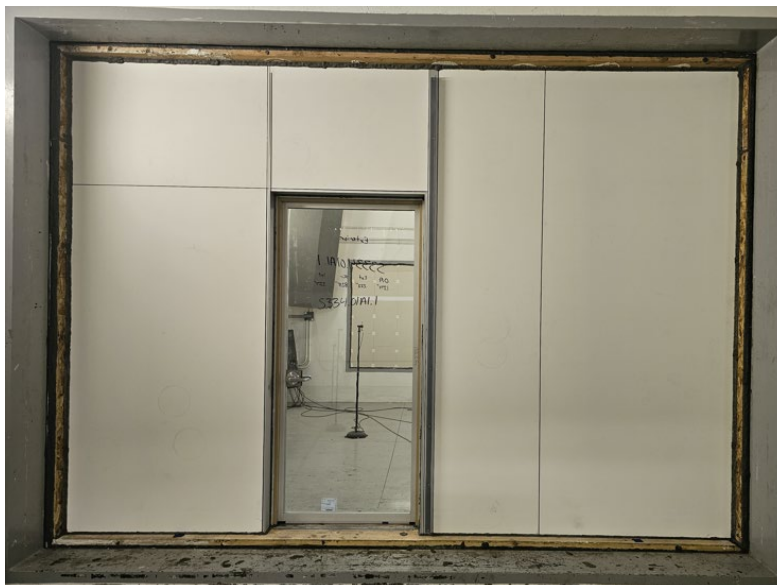
Photo No. 2

Receive Room View of Installed Test Specimen

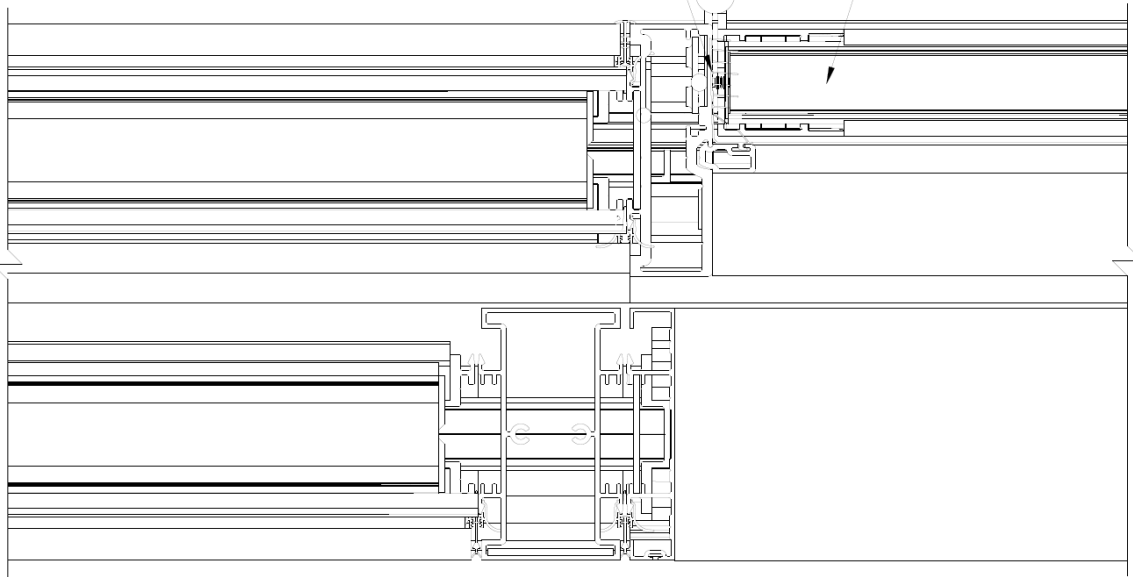
5

BUTT HINGE - SPECTRA DOUBLE PANE DOOR  
HINGE SIDE BASE SEALS

BASE FLAP SEAL

DROP SEAL

| Bottom Rail | Hard Floor Drop Seal (CCE Acoustic ALU). Door Skirt was adjusted to be tight to the floor. Cavity above the door skirt was filled with duct seal. |
| Guide Vertical Seals | Coplanar, <u>enzo</u> , rectilinear door verticals with standard hinges. Flap seals <u>were run</u> the length of the stile and the base flap seals were cut to size to fit tightly from the floor to the underside of the stile. |
